Comprehensive Visualization of Interface Defeat-Based Ballistic Impact Damage in a Titanium Carbide (TiC) Ceramic Target Disk

by William H. Green, Joseph M. Wells, and Nevin L. Rupert

ARL-TR-2565 September 2001

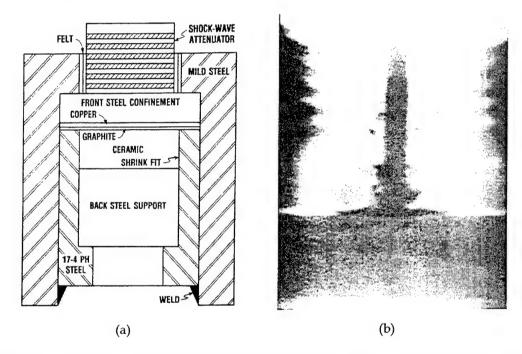
Figure 1. Depictions of (a) schematic of heavy constraint ballistic test fixture and (b) flash x-ray of the penetrator experiencing interface defeat at the front surface of the TiC disk. Not to scale (Hauver et al. to be published).

The heavy constraint apparatus used by Hauver et al. (1994) for confining the TiC ceramic sample disk during the ballistic impact testing is shown schematically in Figure 1(a). A high-speed flash radiograph showing the interface defeat of the impacting penetrator with lateral flow at the front surface of the TiC disk is shown in Figure 1(b). The penetrator was a 90% W alloy short rod with a length-to-diameter ratio (L/D) = 20, and impacted the target at a contact velocity of about 1,600 m/s.

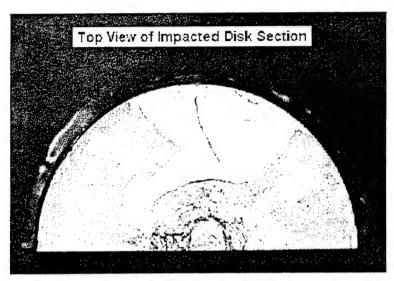
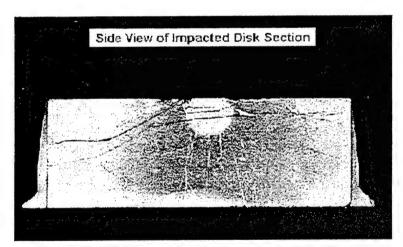
Figure 2. Macrophotograph of TiC ceramic half-disk showing impact surface and damaged zone.

The TiC ceramic sample utilized in this study was provided by George E. Hauver and is one-half of a 72-mm-diameter × 25-mm-thick ceramic target disk section (Figures 2[a] and [b]). A higher magnification view of the sample cross section containing the comminuted zone and the mesocracking is more clearly shown in Figure 3.

a. Macrophotograph of TiC ceramic half-disk, 72-mm in diameter, showing front (interface defeat) impact surface.

b. Macrophotograph of TiC ceramic half-disk, 25 mm thick, showing comminuted microdamaged zone (light circular area) and mesocracking through the thickness of cross section.

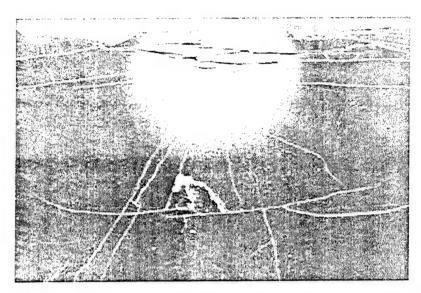
Figure 3. Closer view of the comminuted zone (light circular area) and the prominent mesocracking in TiC disk (LaSalvia et al. 2000).

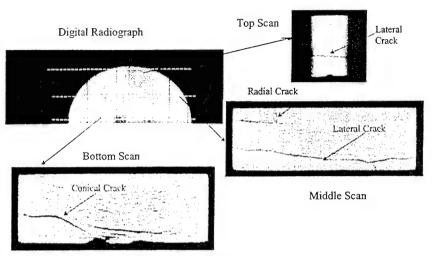
A digital radiograph in the through-thickness direction and three CT slices are shown in Figure 5. The vertical position of each slice is shown on the DR by dashed lines. The purely vertical streaking in the DR and the moiré fringe

Figure 5. DR and 2-D CT slices in TiC sample.

pattern in the bottom CT slices are image artifacts. Mesocracking damage is readily apparent in both the DR and CT slices, even with the artifacts. The impact face is at the bottom of each slice.
